**Flood Control Project Maintenance
Levee Inspections**

Fall 2012 Levee Maintenance Deficiency Summary Report

Sacramento River Basin

California Department of Fish and Game Shea Levee

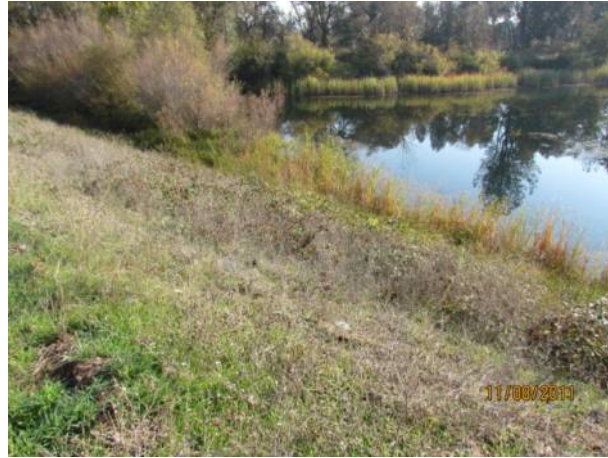
Levee Mile Report Line	4
Start Levee Mile	0.02
End Levee Mile	0.06
Location	Land Side
Category	Earthen Levee
Item	Vegetation

View of the berries vine along the L/S slope.

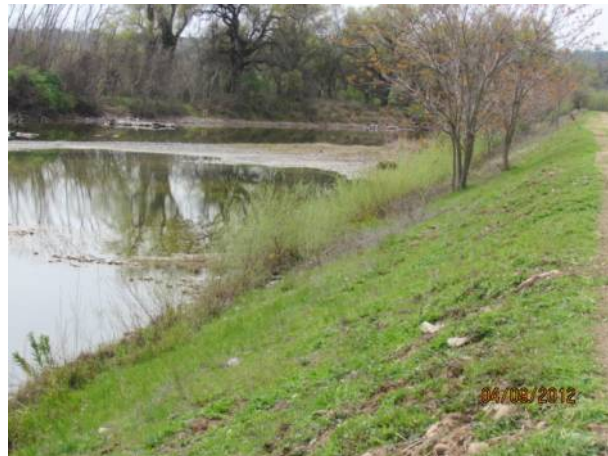
Levee Mile Report Line	6
Start Levee Mile	0.08
End Levee Mile	0.21
Location	Land Side
Category	Earthen Levee
Item	Vegetation

View of the vegetation that needs to be removed from the slope of the levee.

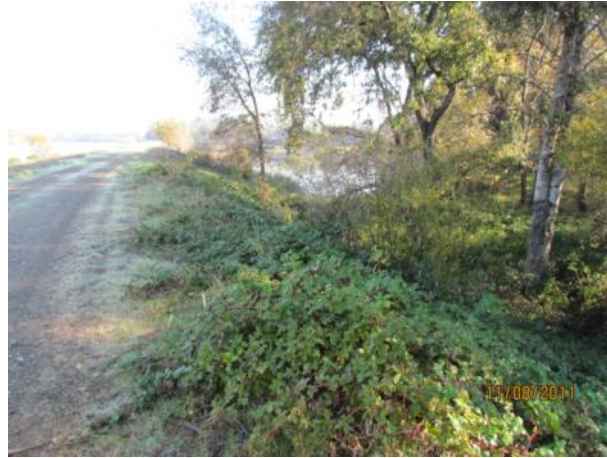
Levee Mile Report Line	7
Start Levee Mile	0.25
End Levee Mile	0.30
Location	Land Side
Category	Earthen Levee
Item	Vegetation

View of the vegetation along the L/S slope.
